HUDSON RIVER BASIN
CAMP HARRIMAN DAM
GREENE COUNTY, NEW YORK
INVENTORY NO. 552

PHASE I INSPECTION REPORT
NATIONAL DAM SAFETY PROGRAM

HUDSON RIVER BASIN
CAMP HARRIMAN DAM
INVENTORY NO. 552
PHASE I INSPECTION REPORT

Name of Dam	CAMP HARRIMAN DAM (I.D. NO. 552)
State Located:	NEW YORK
County Located:	GREENE COUNTY
Stream:	EAST KILL, SCHOHARIE CREEK
Date of Inspection:	AUGUST 30, 1978

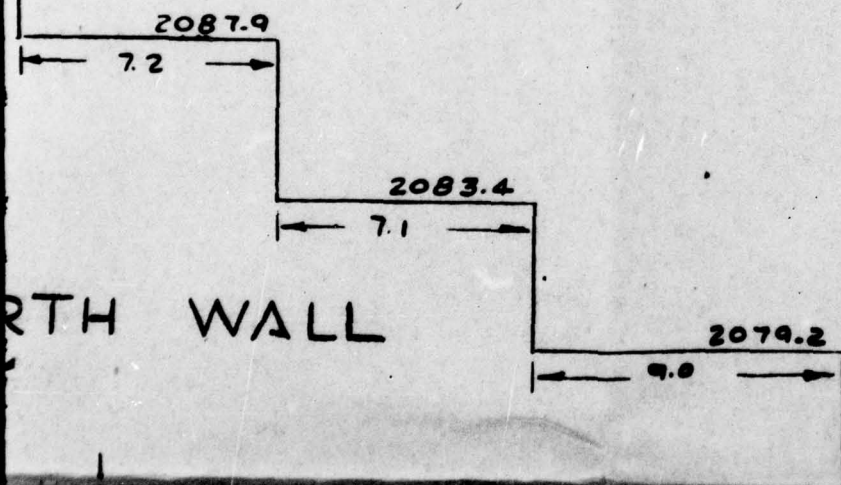
PLAN of MAIN SPILLWAY
SCALE 1" = 5'0"

There has been substantial erosion of the apron. The flagstones have been carried away (possibly after having been loosened by freeze-thaw cycles) and some of the underlying concrete fill has also been eroded. A small amount of soil adjacent to the south (outside) face of the south training wall has been eroded, apparently as a result of overtopping.

c. Erosion of the main spillway apron is considered to be an undesirable condition; additional erosion of the apron could cause undermining of the spillway toe and/or training walls.

CONCRETE APRON
BADLY ERODED

b. The apron of the main spillway should be repaired.

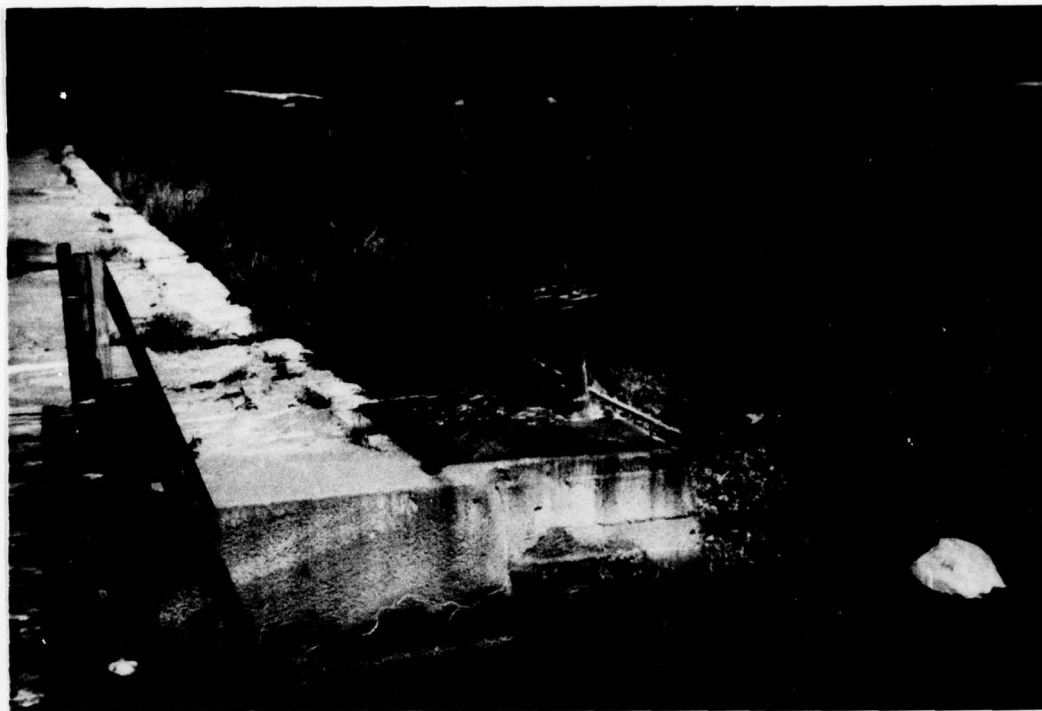
6. Gate operating stand for high level sluice gate, looking northerly

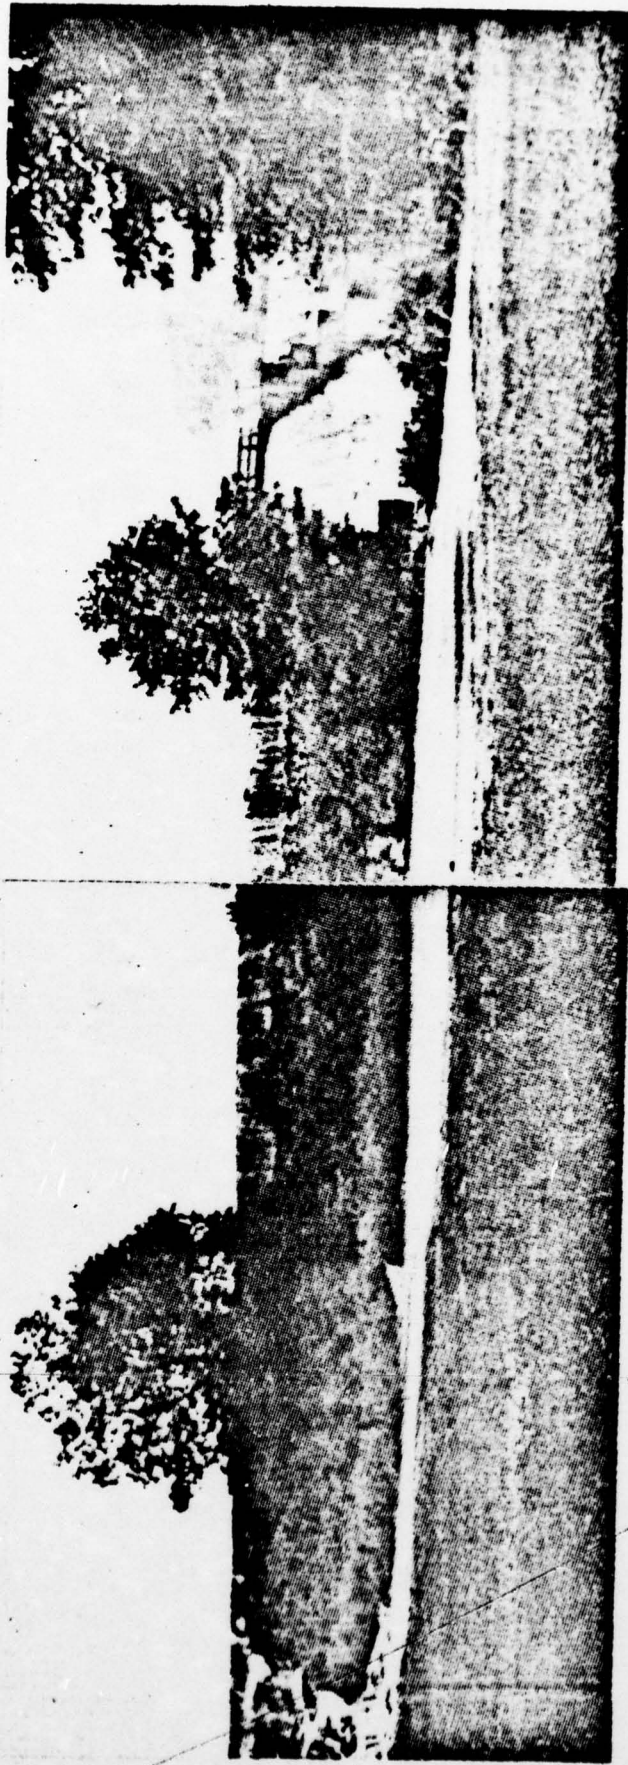
DAM BEING OVERTOPPED WITH 18 INCHES OF WATER

August 10, 1976 7:45 AM
